Manhole Inspection Summary

Manhole # S47E__025MH

Record Plat: **47E** Node: **025** Status: **Found**

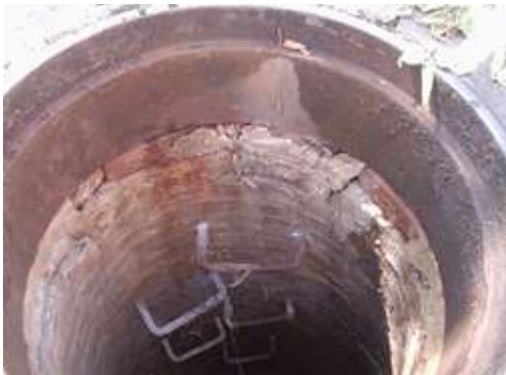
Defect 2

Condition: ☐ Sound ☐ Cracked ☐ Root Intrusion ☒ **Loose Brick** ☐ Deteriorated

loose brick

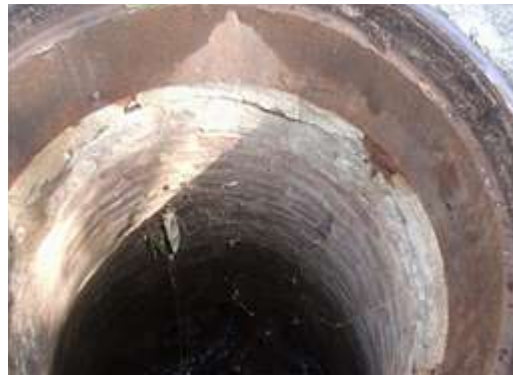
Defect 1

Infiltration: ☐ None ☐ Joint ☐ Cracks ☒ **Mortar** ☐ Roots ☐ Wall

infiltration

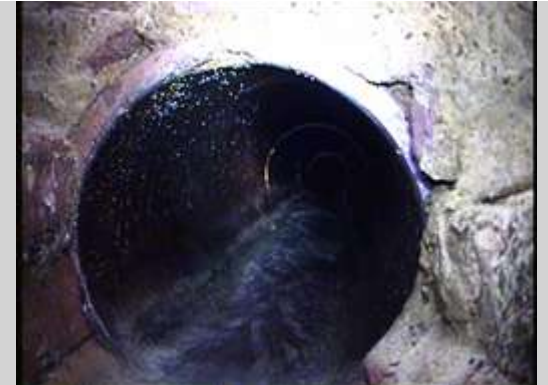
12 O'Clock Outflow

Pipe Height: **8.4** (in.) Rod and Bar (Angled)
Pipe Material: **Clay** ☐ Pipe Lined
Invert Depth: **9.95** (ft.) Flow Characteristics: **Slow**
Deposits: ☒ None ☐ Mud ☐ Sludge ☐ Debris ☐ Grease
Silt Depth: (in.) Deposits Extent:
Infiltration: **None** Pipe Seal Cond: **Sound**

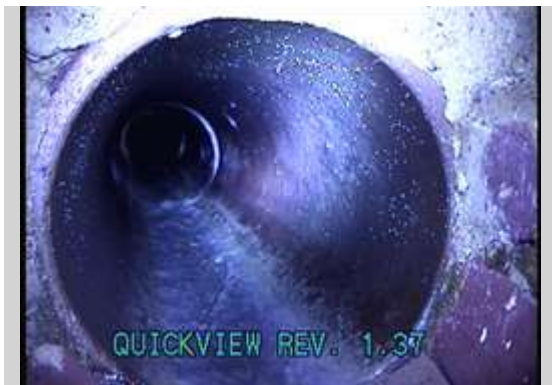
3 O'Clock Inflow

Pipe Height: **8.4** (in.) Rod and Bar (Angled)
Pipe Material: **Clay** ☐ Pipe Lined
Invert Depth: **9.75** (ft.) Flow Characteristics: **Slow**
Deposits: ☒ None ☐ Mud ☐ Sludge ☐ Debris ☐ Grease
Silt Depth: (in.) Deposits Extent:
Infiltration: **None** Pipe Seal Cond: **Sound**

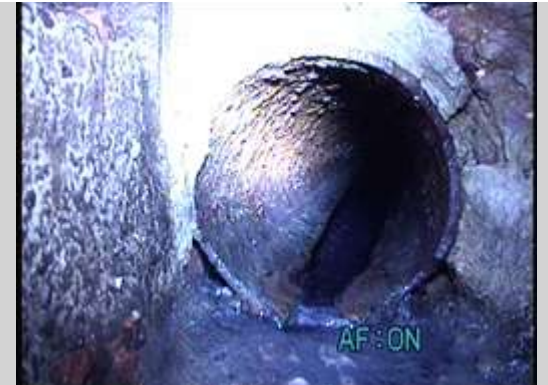
6 O'Clock Inflow

Pipe Height: **8.4** (in.) Rod and Bar (Angled)

Infiltration: **None**

Pipe Seal Cond: **Sound**
